## Centennial Comfort Stations

Centennial Comfort Stations  
Fairmount Park  
Philadelphia, Pennsylvania

City of Philadelphia  
Capital Programs Office

2006      Design and Documentation

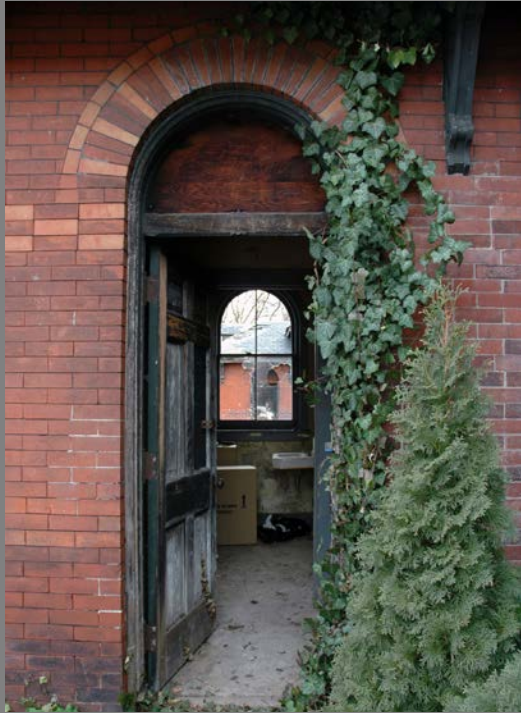
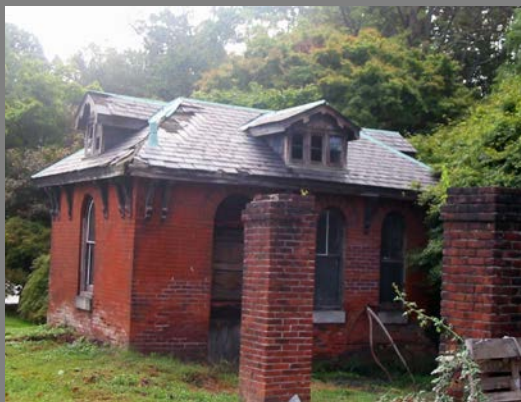
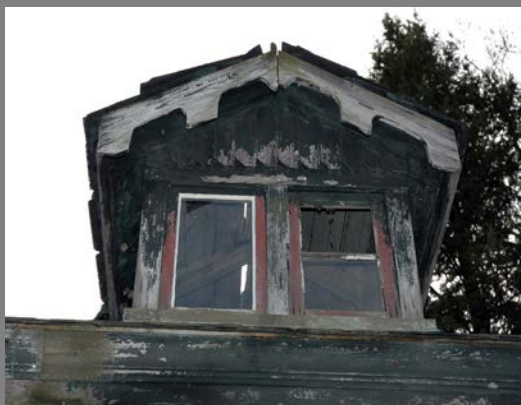
The Centennial Comfort Stations are two masonry buildings with slate roofs and wood fenestration. The former restroom facilities date to the Centennial Exposition in 1876.

Years of neglect and foundation failure have resulted in structural displacement and deformation. The masonry structure, wood elements and roofing are all in a state of failure.

Recommended to excavate and rebuild the foundation to stabilize the masonry building.

Recommended the replacement of the brick and repoint where necessary to minimize water infiltration.

Recommended replacement of the roof and installation of copper gutters to direct storm water away from the buildings.

Recommended the repair of all wood windows, including all decorative trim and soffits, to restore both buildings to their original appearance.
