Fox Chase Barn

Fox Chase Barn
Philadelphia, Pennsylvania

Friends of Fox Chase Farm

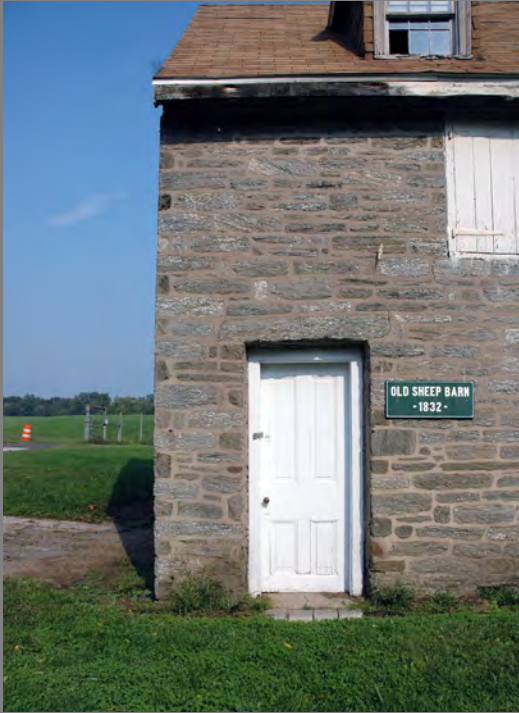
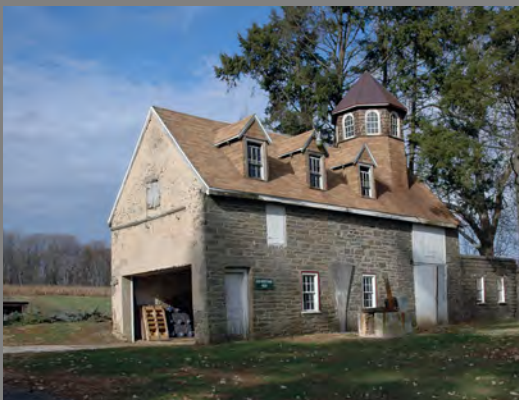
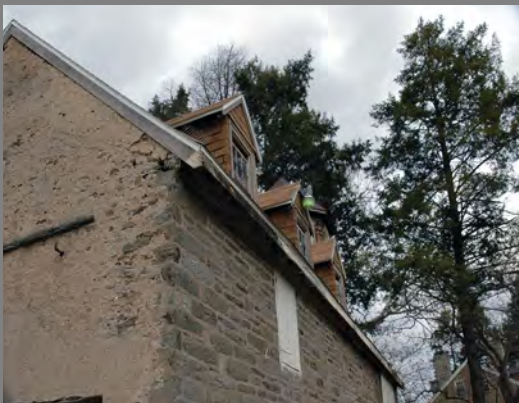
The Sheep Barn located on Fox Chase Farm in Philadelphia, has had several additions built to the original barn, constructed circa 1832. The addition on the southern side of the barn was displaced dramatically, with the opposing walls moving away from one another.

Developed repair methods that involved installing a series of through-rods to tie the walls.

Provided construction documents to reconstruct unstable portions of masonry walls.
